Contract Report GL-95-1
September 1995

Acoustic Emission on Cofferdam Distress Warning System and Ancillary Acoustic Emission Monitoring; Melvin Price Locks and Dam (Phase III)

by Ground Engineering, Inc.

Final Report

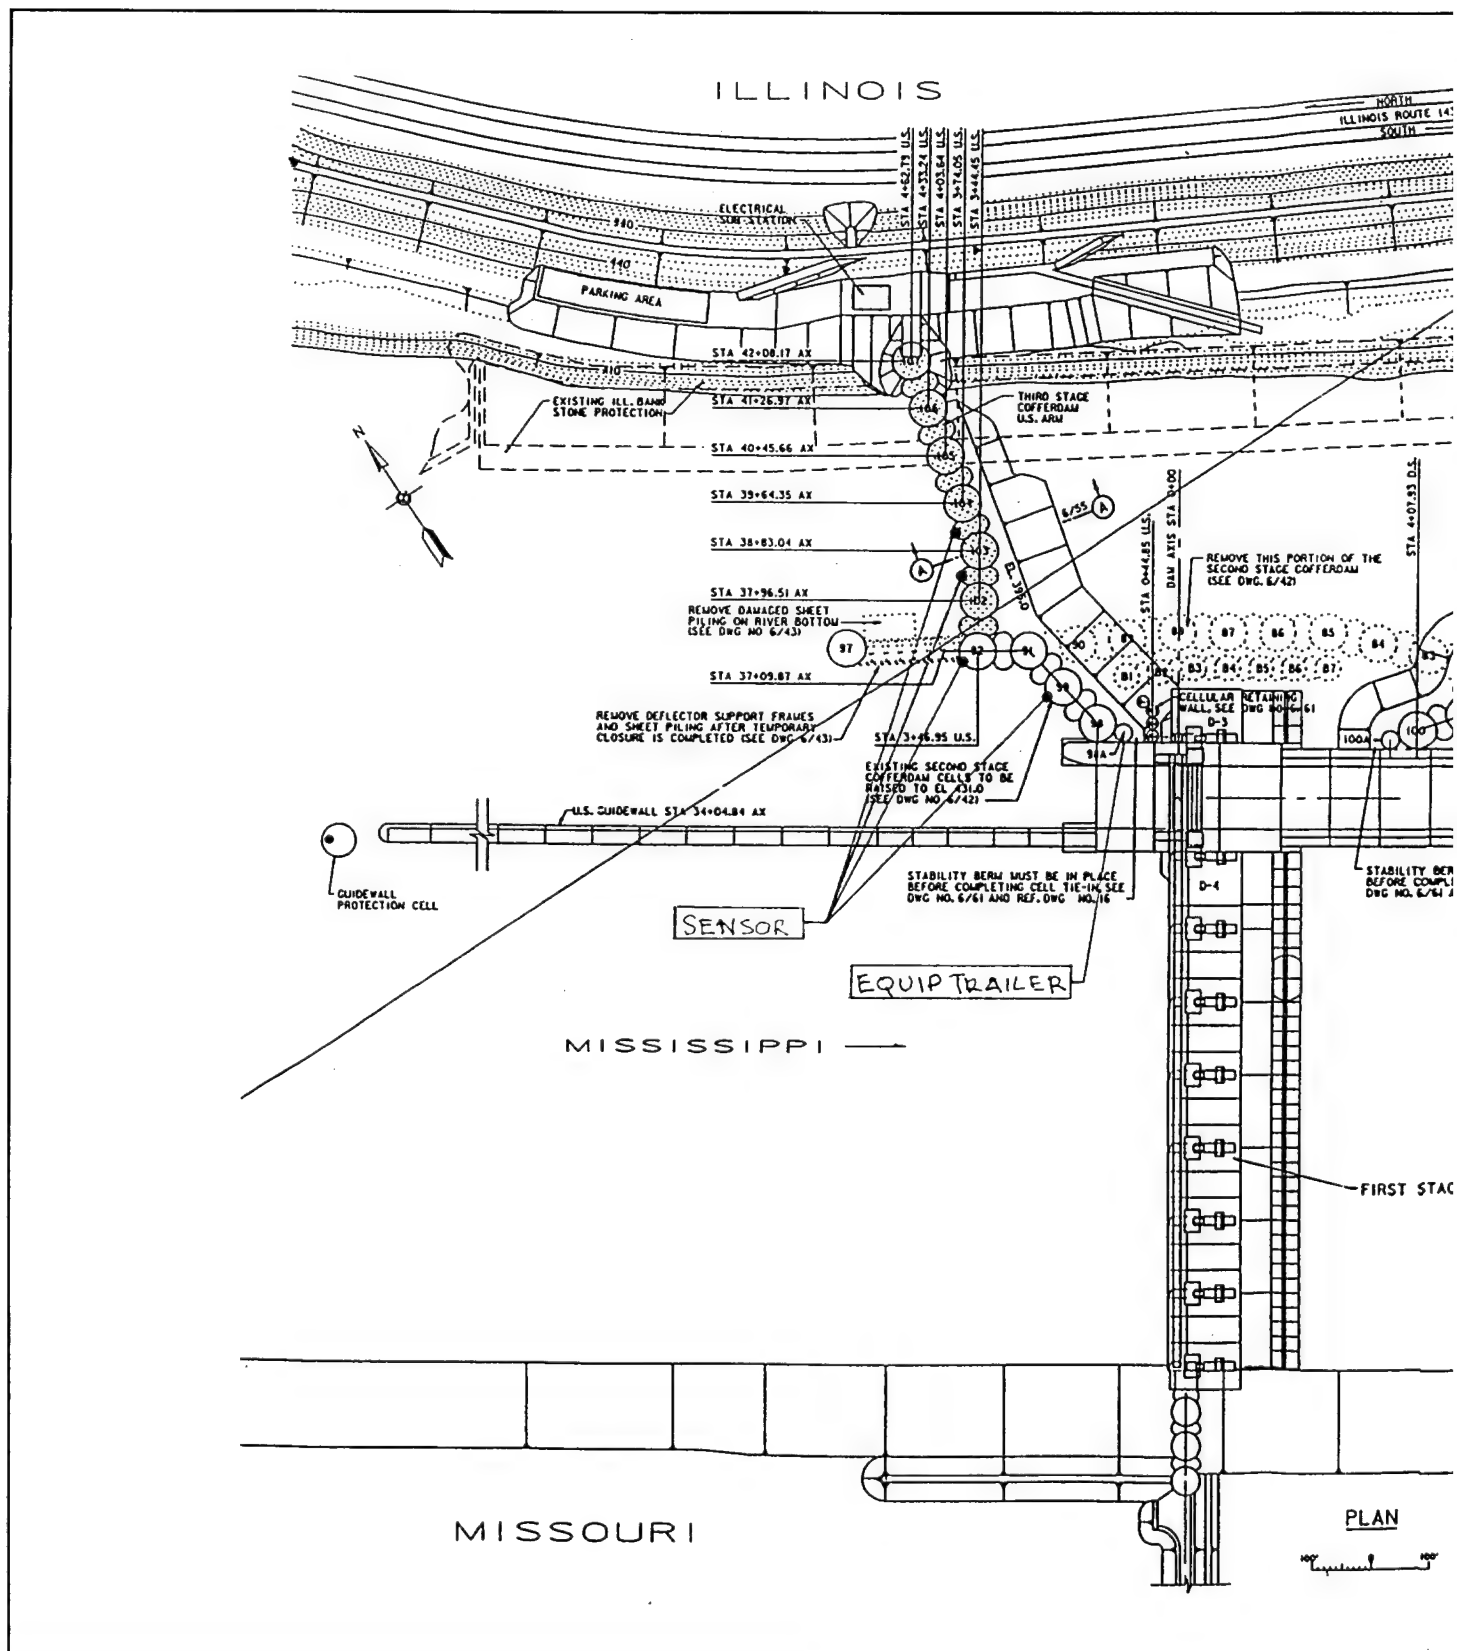
Figure 1. Site plan

The DWS was installed on the north leg of the cofferdam. The equipment trailer was located on Cell 98A, see Figure 1, and Photo 4, and the sensors were located on cells 99, 92, and the Connecting Arcs between Cells 102-103 and 103-104. See Figure 1 and Table 1 for more specific location details. As indicated above the original plan had been to locate sensors on every other cell. This would have resulted in sensors located on Cells 99, 92, 103, and 105. However, the Construction Contractor established a sand unloading operation in the area from the Illinois shore to the Connecting Arc between Cells 104 and 105. In addition, concrete for the upstream guidewall was placed via conveyor from Cell 104. As a consequence of these construction operations the sensor locations given above were selected as the most suitable.

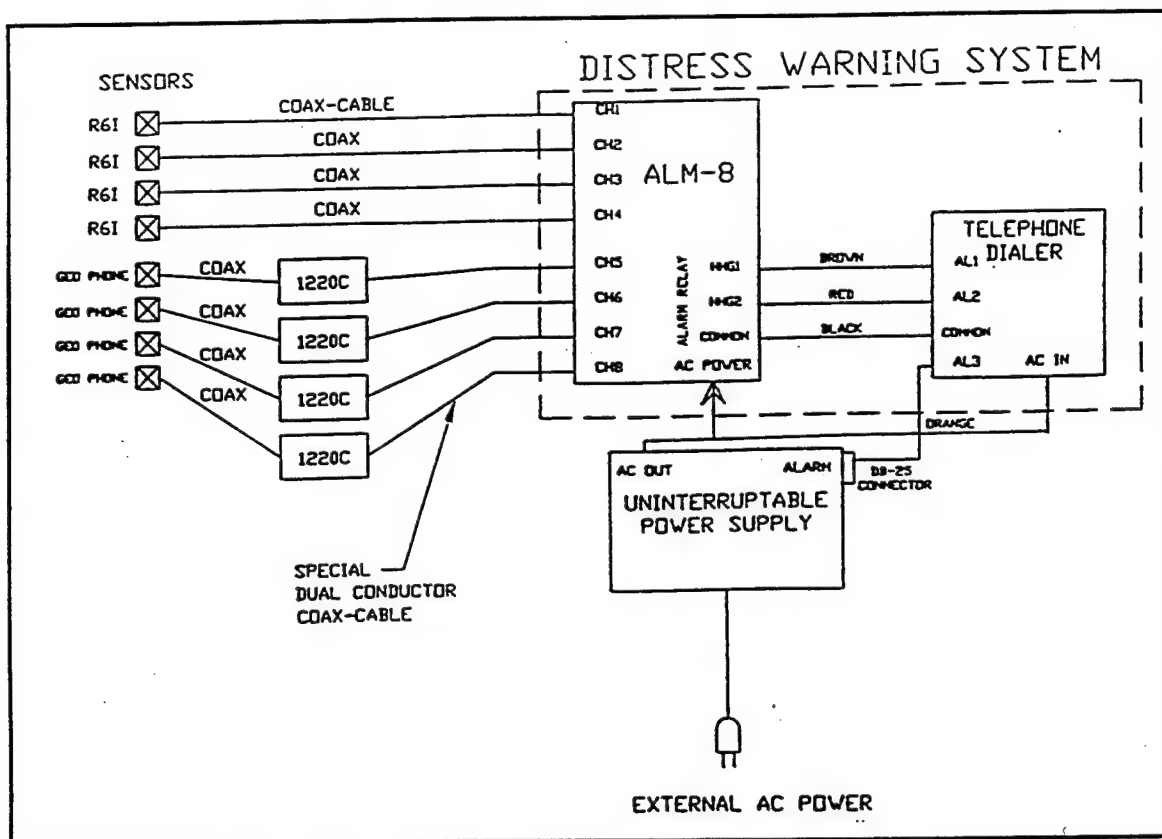
Figure 2. Distress warning system schematic design

A schematic system design is given in Figure 2. It is based on the system described in Sections 9.4 and 9.5 of the September 1989 report. As shown in Figure 2 the DWS monitored four locations. Each monitoring station included a 60 KHz AE sensor, such as was used in the preceding studies listed above, and a geophone. The function of the AE sensor was to record signals generated by high river levels (large hydrostatic forces) and/or damage to a cell from rupture, leakage of cell fill, etc. The function of the geophone, which is a very low frequency sensor, was to record signals generated by an impact on a cell such as from a runaway barge. Such an event would be similar to the large low frequency movements of a seismic event for which geophones are the detection device of choice. The proposed location of the monitoring stations was on every other cell, or approximately 180 ft apart. This spacing was selected because it was believed that the physical events which would generate an alarm would propagate at least half this distance. The AE signals detected by the sensor and/or geophone were carried to the DWS Unit by connecting cables. The DWS Unit, in turn, transmitted a warning message to the Control Room of the Main Lock by telephone.

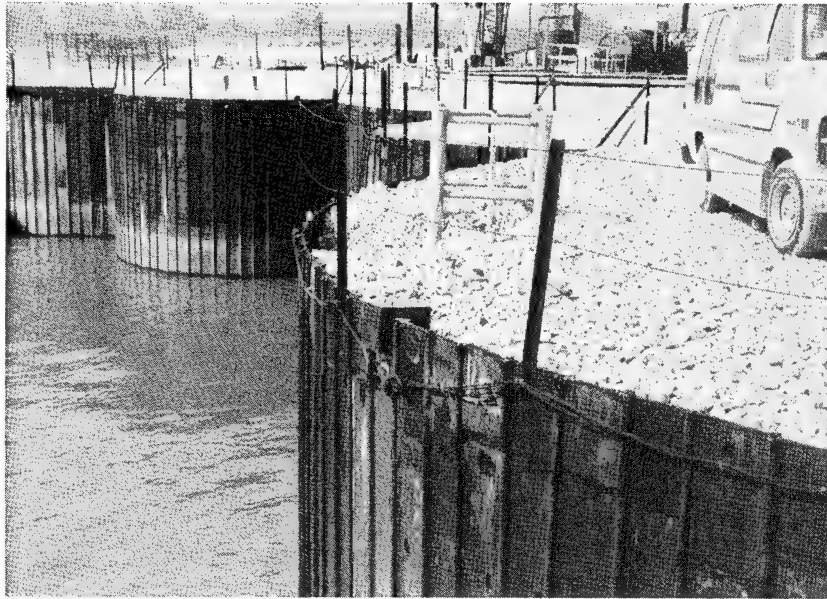
Photo #5 - Sensor Enclosure Box & Connecting Cables

At each location the AE Sensor, Geophone and Preamplifier were housed in a specially fabricated box attached to the top of the sheetpile cell wall. The boxes were painted red to make them clearly visible. See Photos 5 and 6. The AE Sensor was attached to the sheetpile with a specially fabricated magnetic holddown. Before attachment the sensor face was coated with silicone grease to provide complete contact. In addition the joint between the sensor and the sheetpile were caulked with silicone to prevent the entry of water. The Geophones were bolted to an angle which was in turn clamped to the sheetpile. See Photo 7. The Geophones have an integral level bubble and must be installed level. The clamp arrangement permitted sufficient adjustment to accomplish this. The Preamplifiers were also supported by an angle and clamp arrangement. Table 2 provides a summary of AE Sensor, Geophone, Preamplifier, and Cable Number for record purposes. It also provides

The connecting cables were attached to the posts of the guard rail which followed the configuration of the sheetpiling. At each post the cable was attached to a screw clamp with a cable tie. The screw clamp was, in turn, attached to the guard rail post, see Photo 5. Waterproof red plastic tags were attached to the cables approximately every 6 to 8 ft to alert construction workers and others that the cables were not to be disturbed. The tags had the message "TEST CABLE" printed on them.
